Case Study

On 11th July '03 at 1400 hrs, a contractor (M/s. Assam Transport) truck collided with an on-coming truck on NH6 near Deori Village, Chattisgarh approx. 1030 kms east of Mumbai.

Castrol Lubricants / India / LSC
Contractor & 3P FATAL ACCIDENT INVESTIGATION REPORT

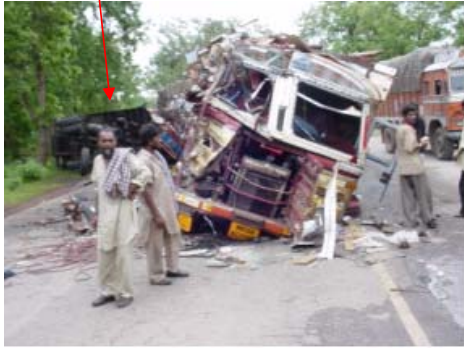
Vehicle 4410

- The impact of the accident resulting in death could have been avoided if not for the wooden cabin of truck 4410. Replace wooden cabin with metal or fibre glass cabin
- For all manor routes, drivers must have access to details of the nearest emergency centre – because it took 2 ½ hours to reach the injured to the hospital. This delay may have contributed to the fatalities.
- The local management must re-iterate the importance of wearing seat belts, as it is considered that the ejection of the driver assistant of 4410 during the impact would not have occurred if he was wearing one.

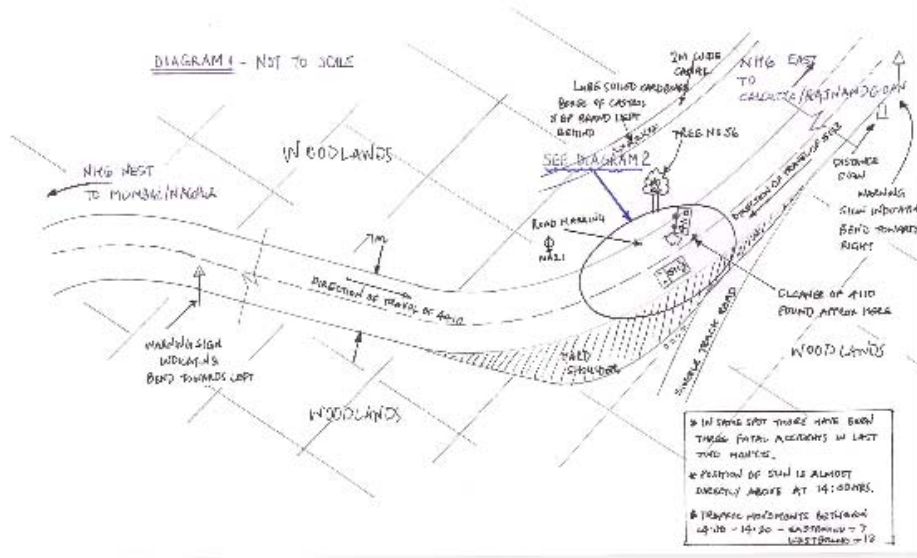
Iron Ingots. Impact occurred to front right side of both trucks (driver side) and the right side of the container of AT vehicle is crushed. Both the vehicle travels a distance of full-length of each other, rubbing alongside each other.

Due to sudden retardation of speed on its right side, 4410 swivels clockwise 110 deg and then overturned on its left side (driver assistant's side). The AT truck's cabin, constructed in a combination of wood and steel, completely crashed due to the impact. The BI vehicle stopped after travelling 5 metres on the correct side of the road. Due to the impact, the front wheels and axle of BI vehicle gets dislodged from the vehicle.

Accident photo (5113 facing us) & 4410 at the back

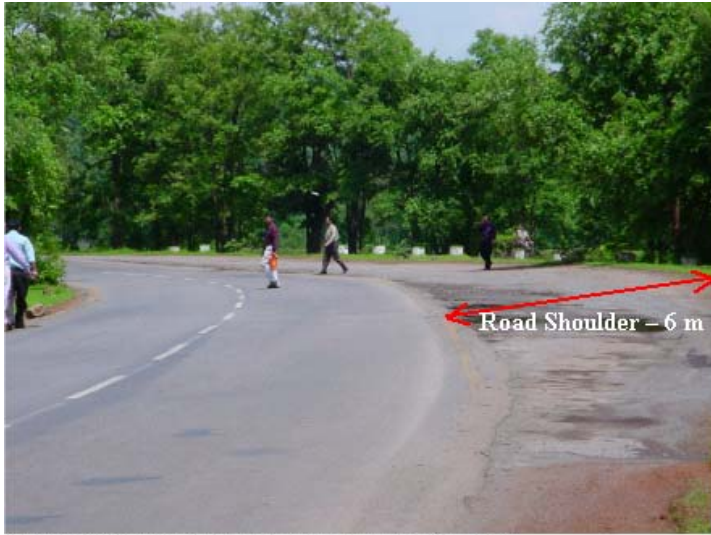
Crescent shaped shoulder

Crescent shaped hard shoulder was very misleading. It leads drivers to believe that the road is wider than what it actually is.

Design of hard shoulder misleads drivers.

View from the direction of travel of 4410. View of crescent shaped shoulder misleading.

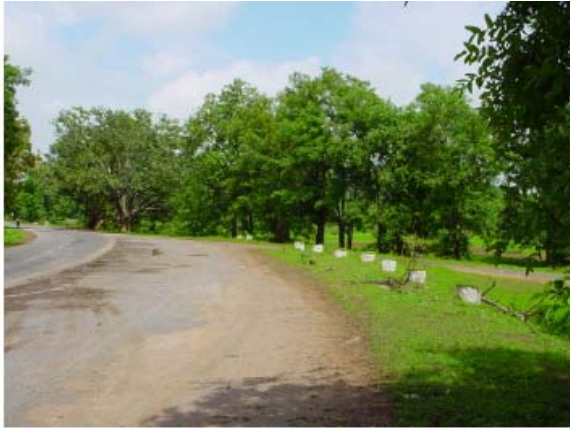
A close up photograph showing the Road shoulder.

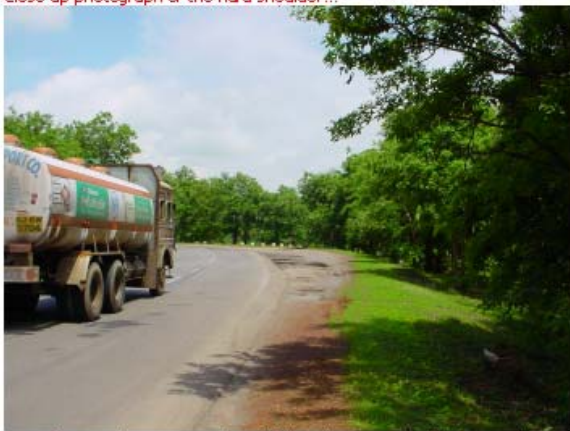
The width of the road is 7 m along the highway and the width of every truck is approx. 2.5 m. That leaves theoretically 2 m width between two vehicles crossing each other. However it is a general tendency in India among truck drivers, not to drive towards the side of the road due to various reasons - height difference between road and shoulder, villagers walking alongside the highways, stray cattle along road side and so on. Typically every trucker leaves 0.75 m of space to his left while driving, which leaves just half a meter gap between two oncoming vehicles - at relative speeds exceeding 80kmph. On a normal stretch of road, a driver is expected to factor this allowance and drive slower than normal around a bend. However at this site, due to the presence of hard shoulder, the road appears wider than normal viewed from the direction of travel of vehicle 4410 (increasing from 7m to 12 m approaching towards the center of crescent (kindly refer photos in appendix 1) which leads drivers not only in driving over centerline but also in continuing at the same speed around the bend.

Close up photograph of the hard shoulder...

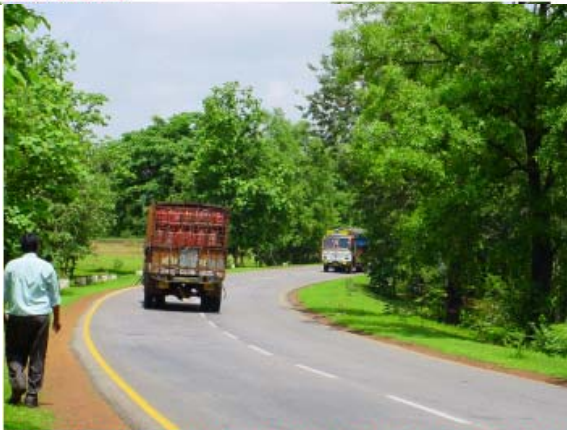
The investigation team visited the accident site and observed the traffic behavior at the bend near the accident site. Out of 20 vehicles observed (10 from each side) - we observed more than 70% of vehicles are driving past the centerline. This led us to come to the conclusion that the crescent shaped hard shoulder is misleading vehicles coming from Mumbai that the road is much wider than what it actually is...

A truck pictured as it approaches left hand curve. Typical behavior (crossing center line) - Observed at site

Trucks crossing center line - Driving behavior at the site. (crossing center line)
