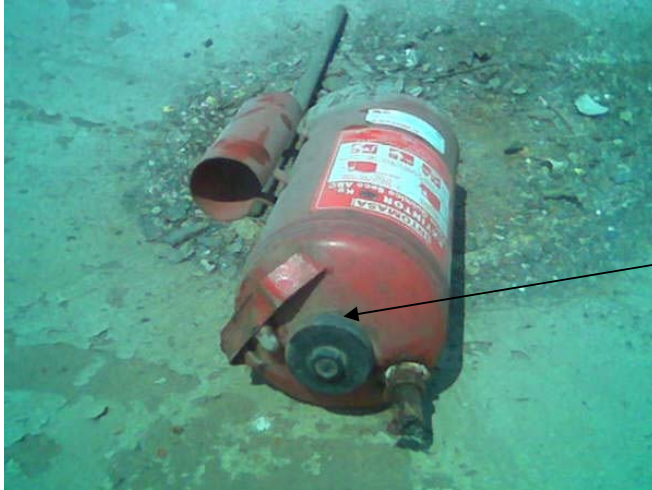
Extinguisher shows signs of corrosion in several parts.

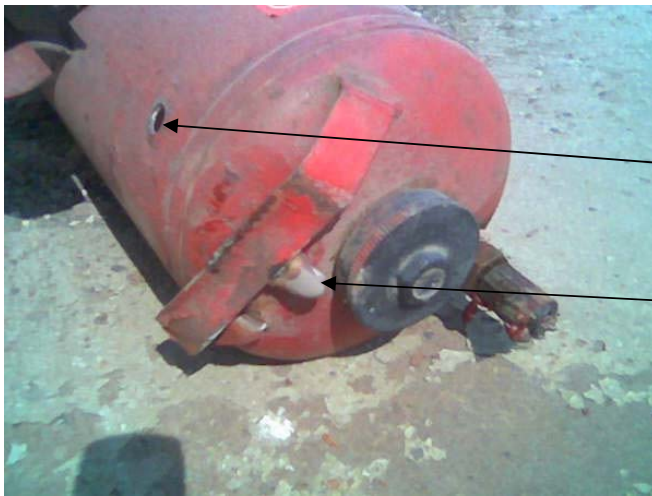
Connection hole to the pressure cylinder/valve.

Part of the victim's finger.

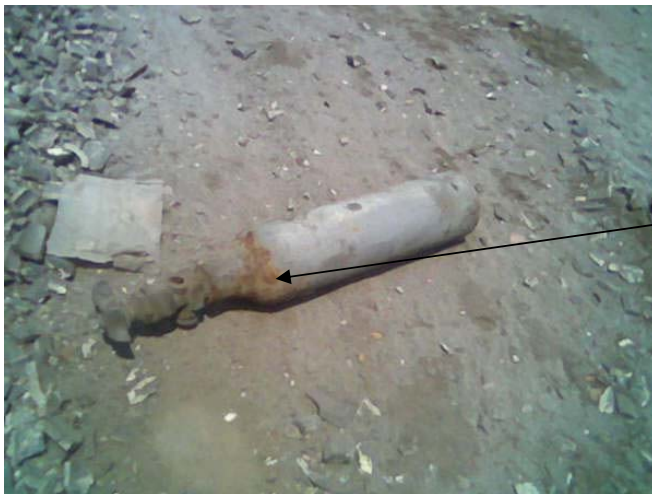
Pressure cylinder/valve with signs of corrosion.

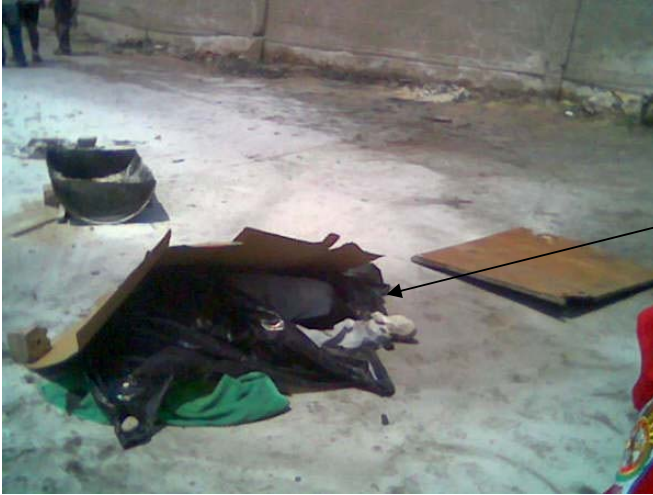
Training area and the victim.

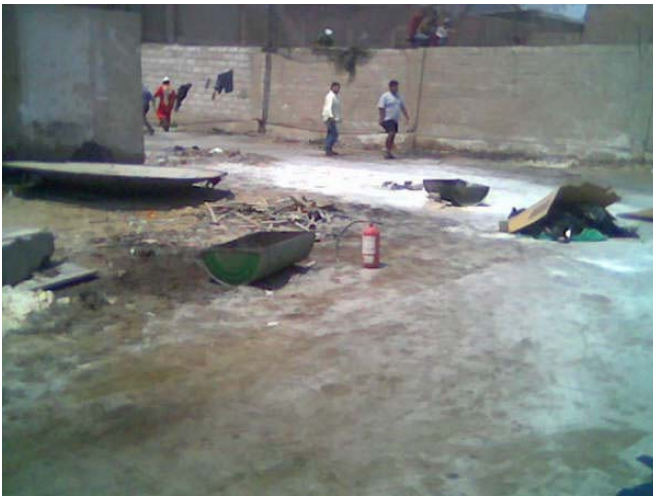
Training area and the victim after the accident.

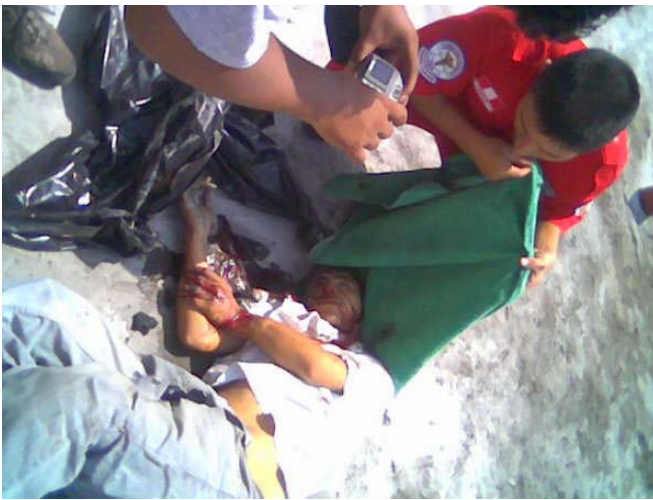
Death was caused by injuries on the victim's neck and face.

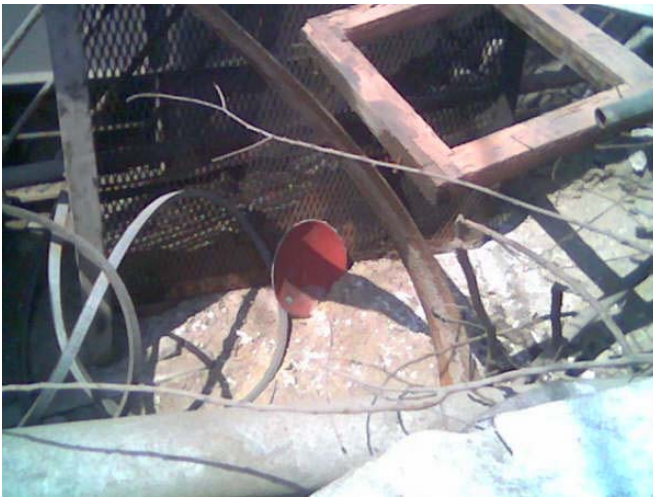
Extinguisher bottom was found far away from the accident site.
