# MUMBAI HIGH NORTH ACCIDENT

**Presentation to Marine Safety Forum**

HSE Offshore Division

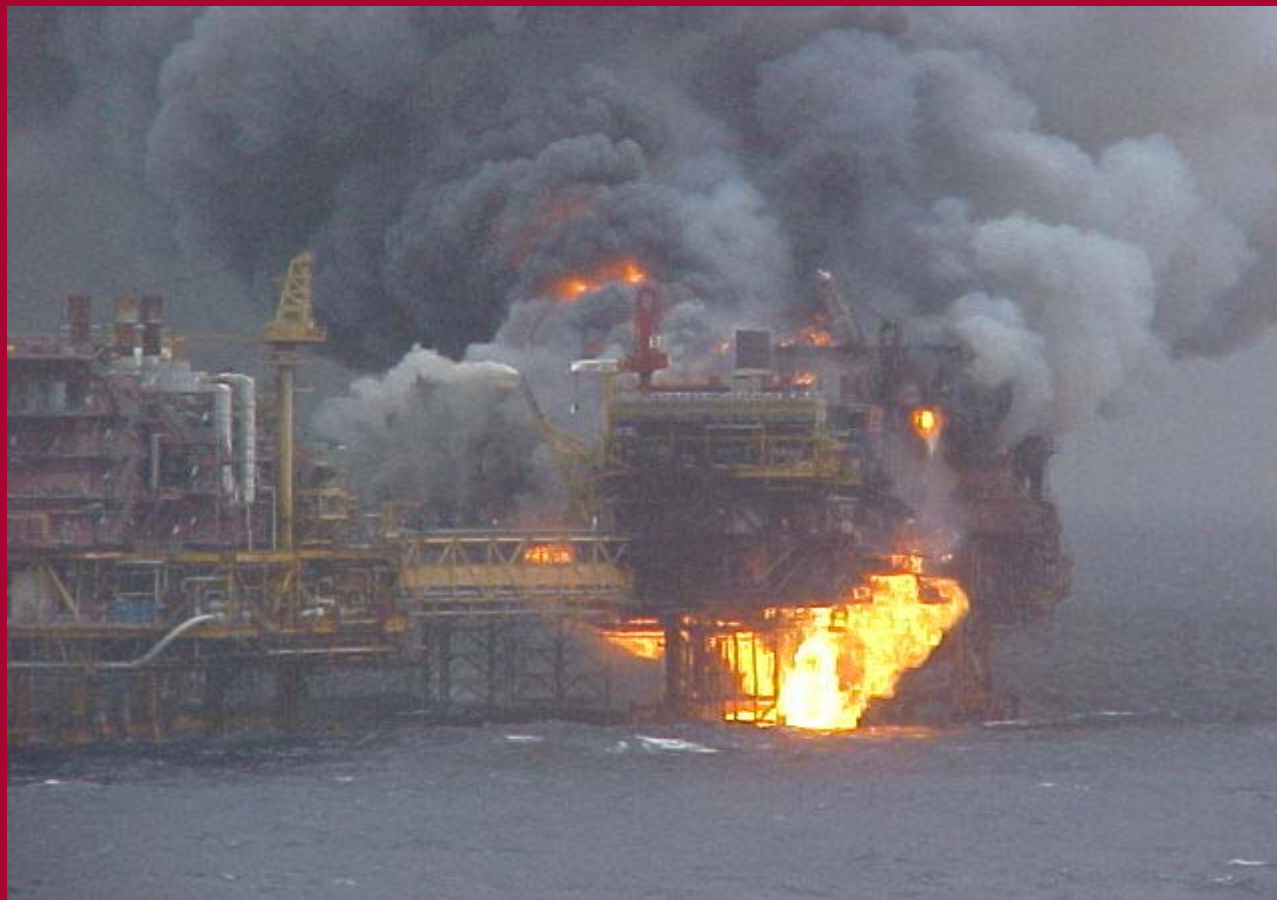
# The fire

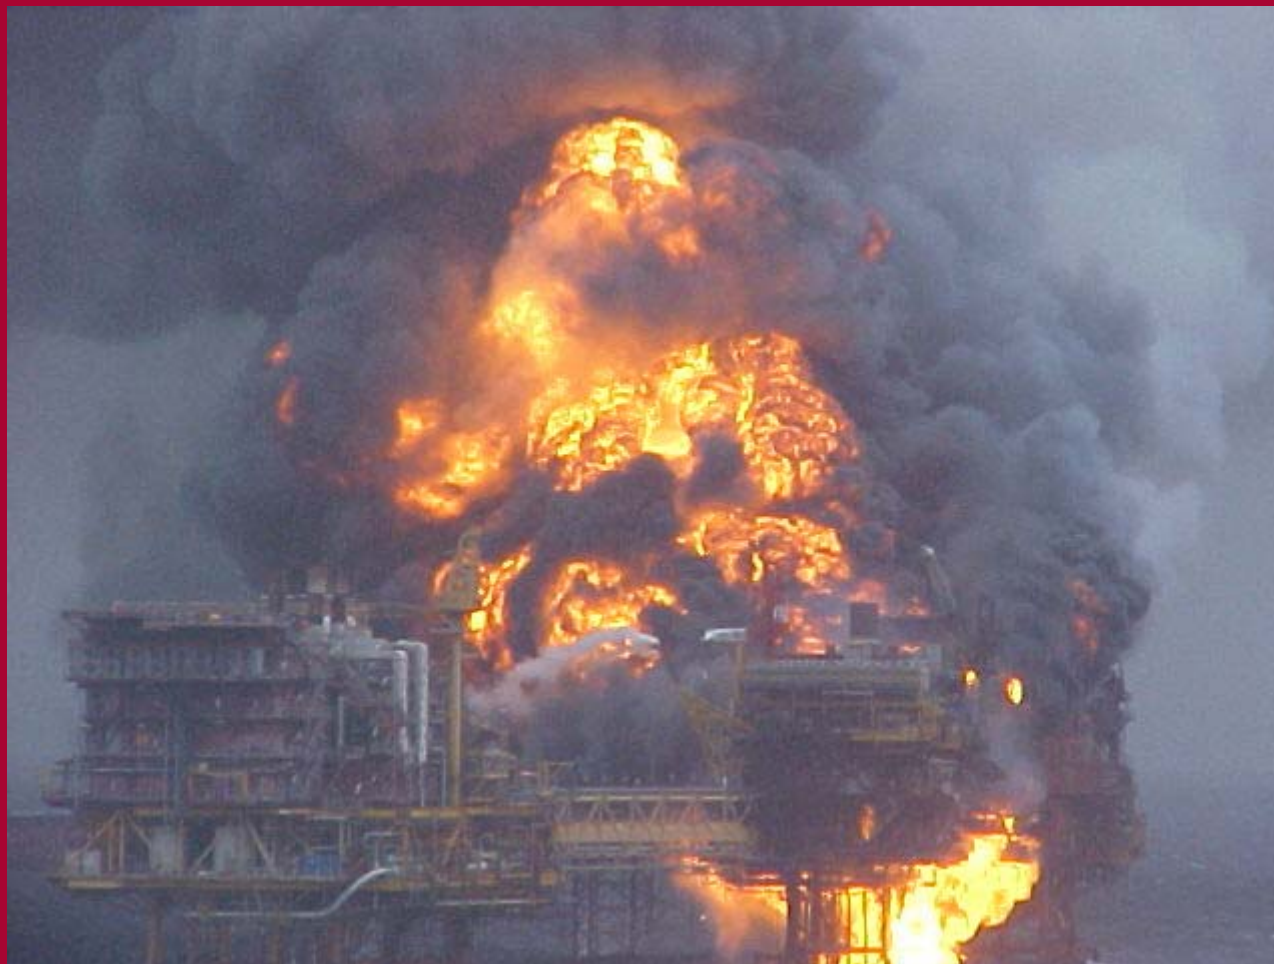
# The fire

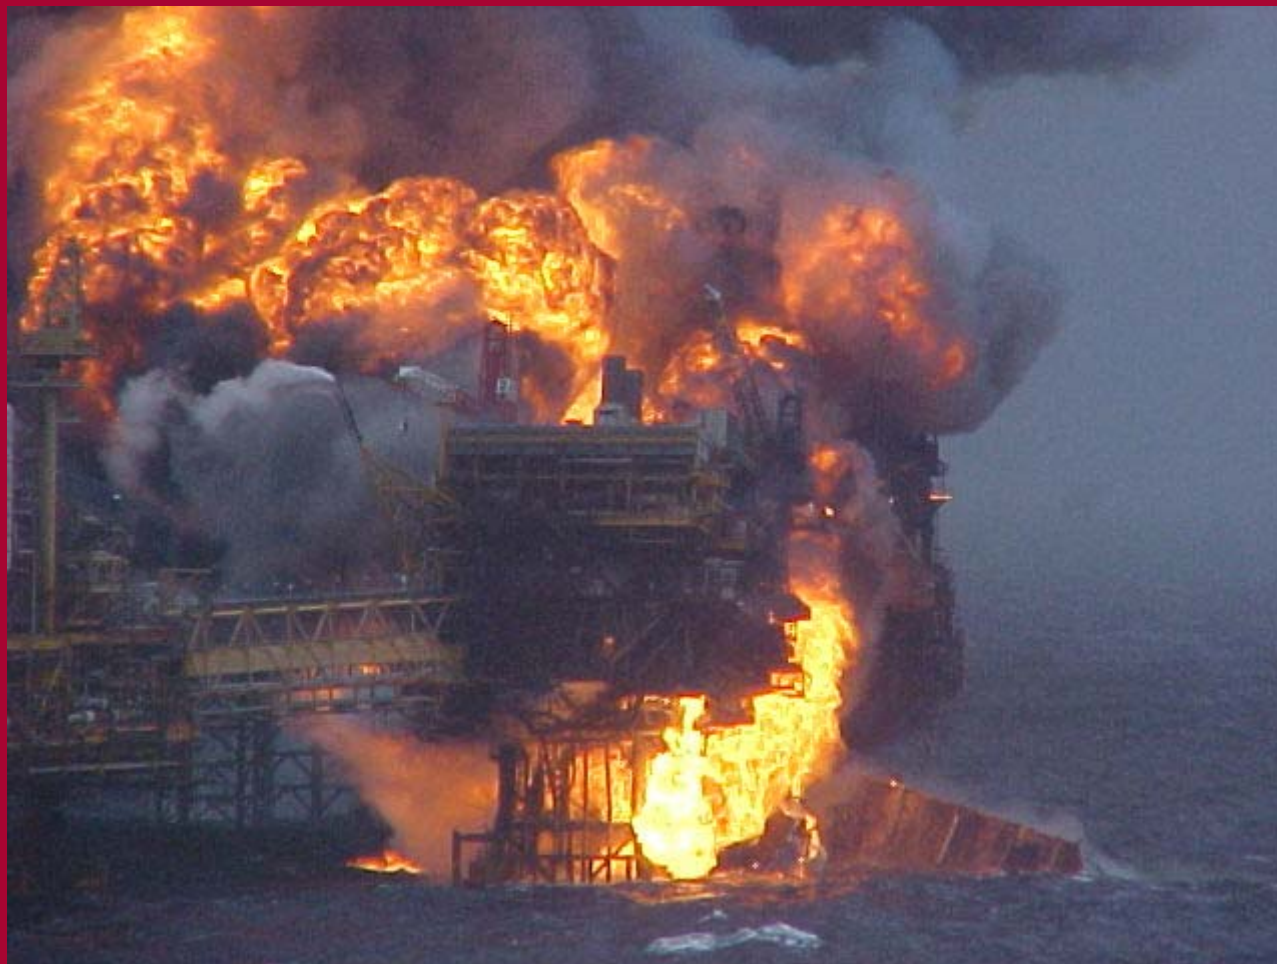
# The fire

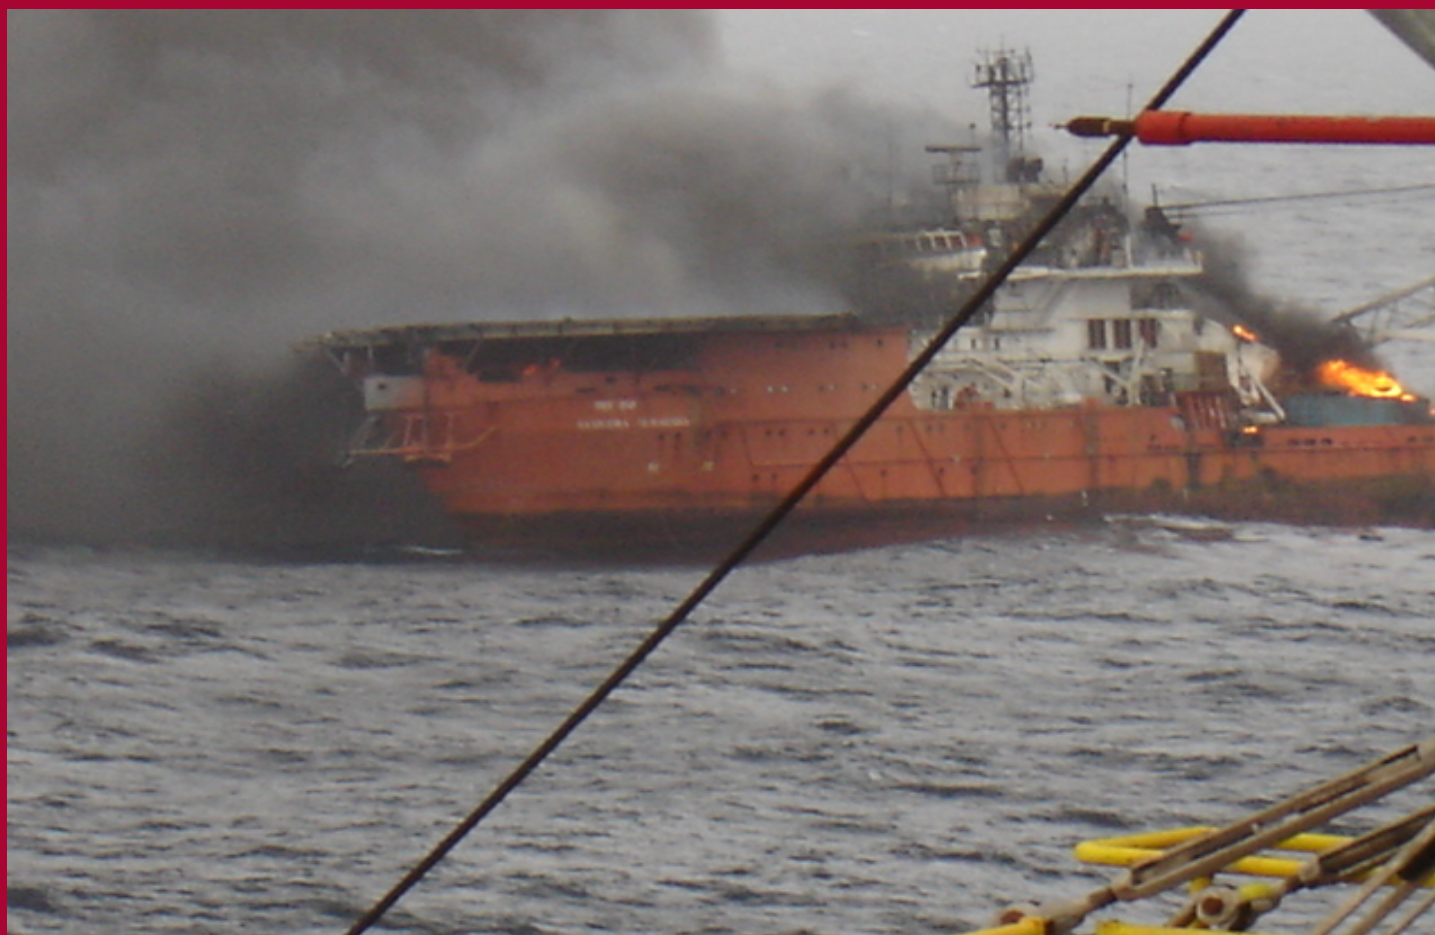
# The MSV

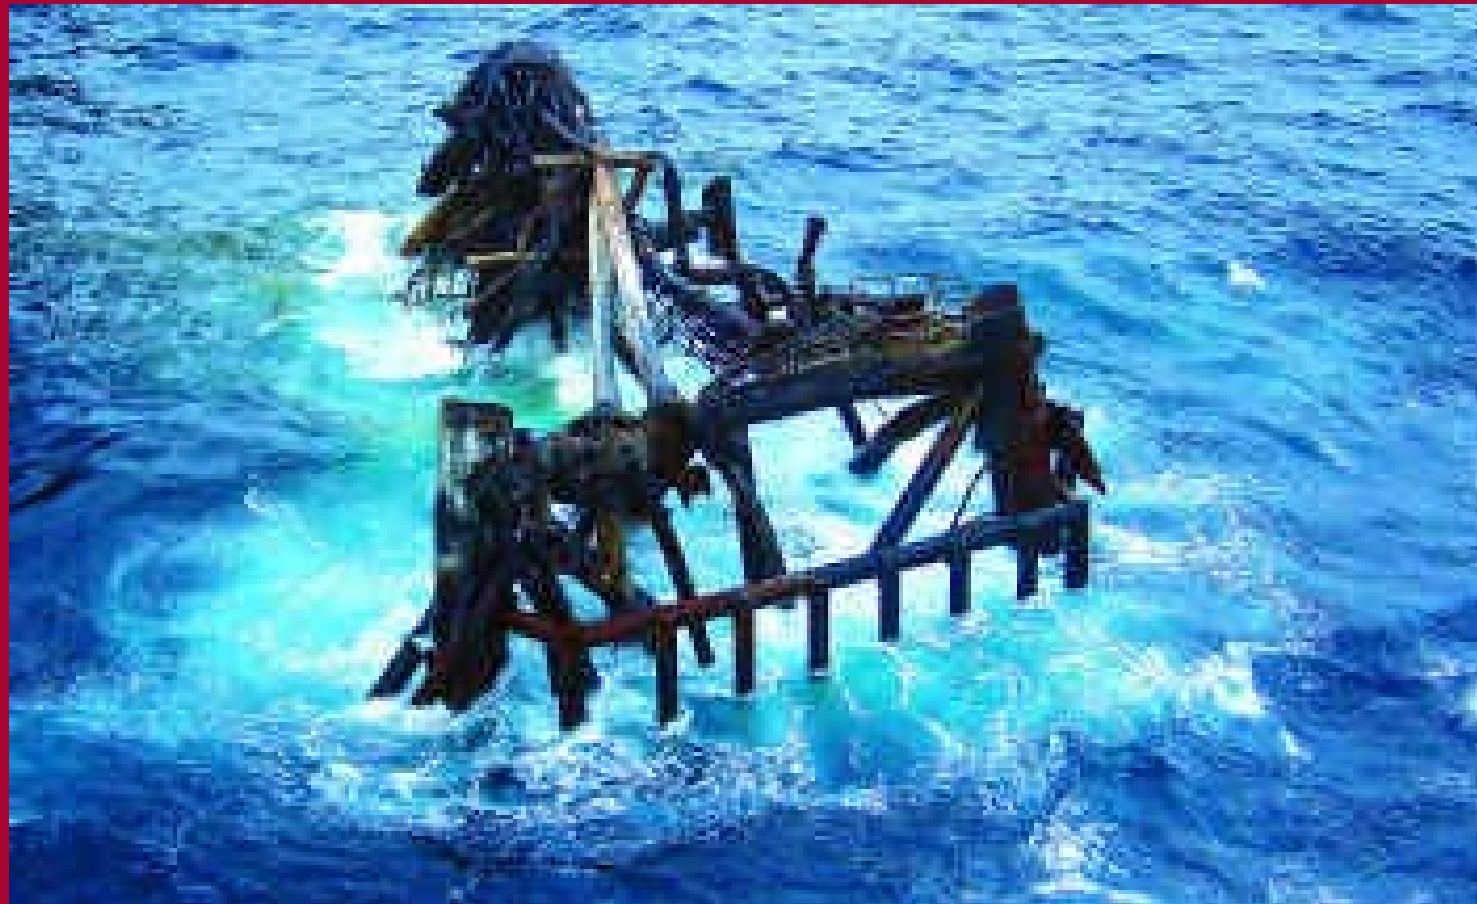
All that was left.....
